Temporal Plots of Field and Laboratory Data for Each Site Sampled in 2011 and 2012

Report 4.2.3

Ecological Engineering Research Program
School of Engineering & Computer Sciences
University of the Pacific
3601 Pacific Avenue
Chambers Technology Center
Stockton, CA 95211

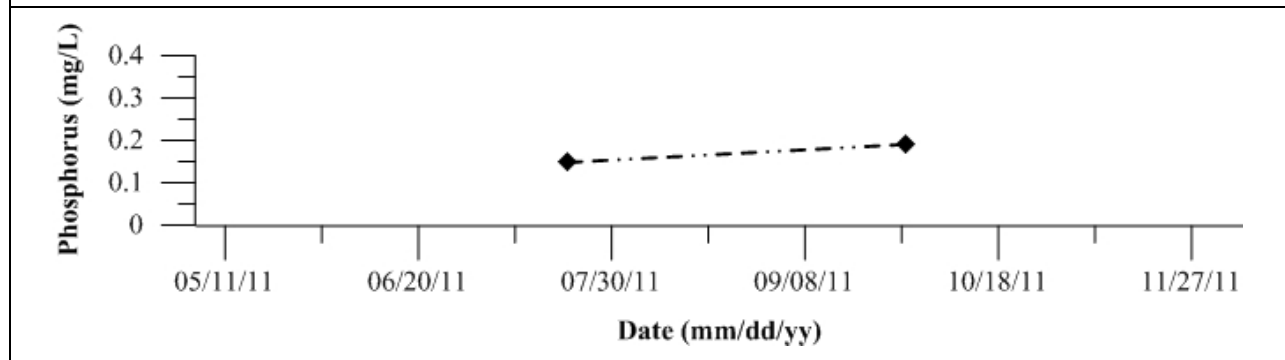
Figure 689: Total phosphorus as phosphate for Site 44 San Luis Drain End. Data collected in 2011.

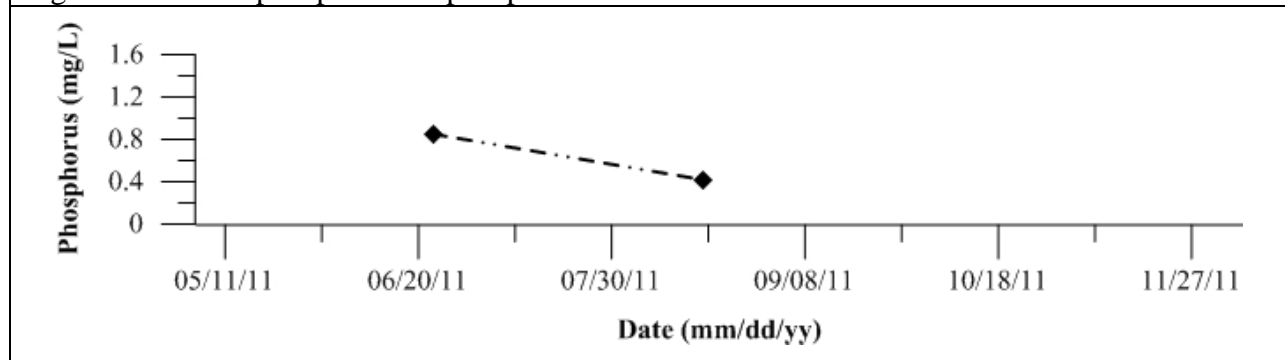
Figure 690: Total phosphorus as phosphate for Site 57 Ramona Lake. Data collected in 2011.

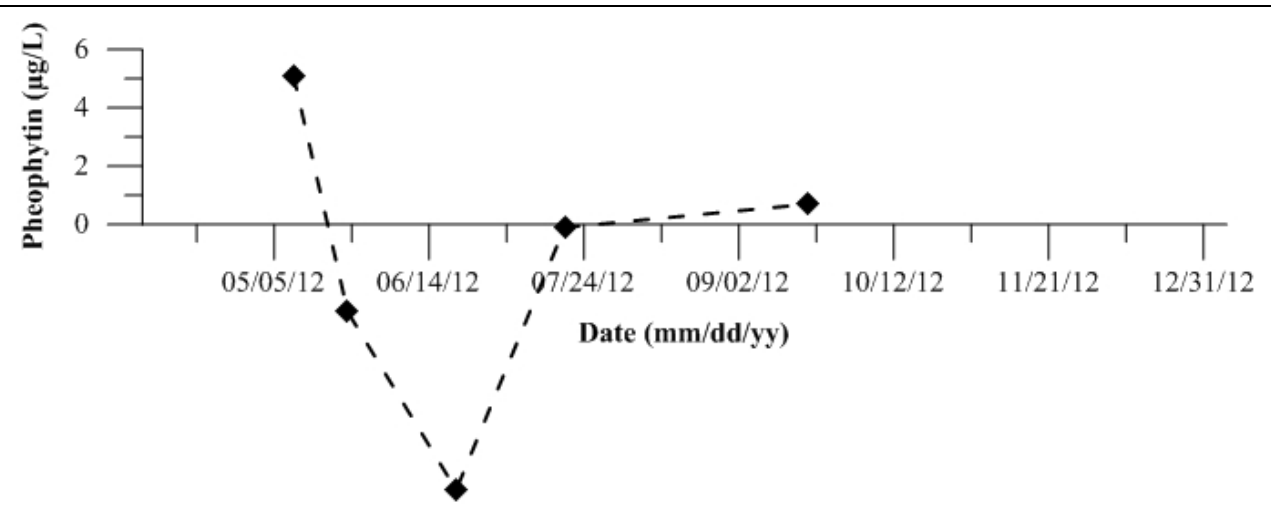
Figure 1729: Pheophytin as determined by spectrophotometric methods for Site 7 SJR at Patterson. Data collected in 2012.

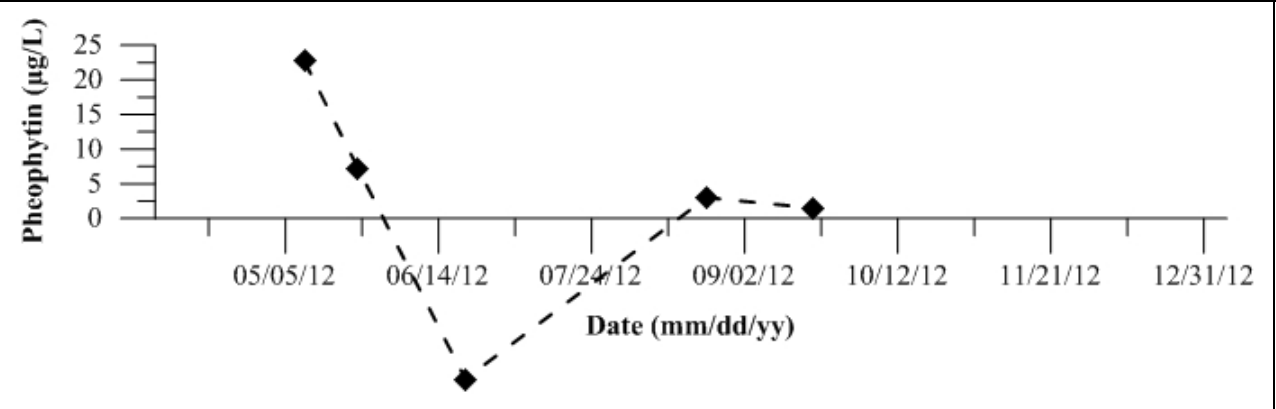
Figure 1730: Pheophytin as determined by spectrophotometric methods for Site 10 SJR at Lander Avenue. Data collected in 2012.

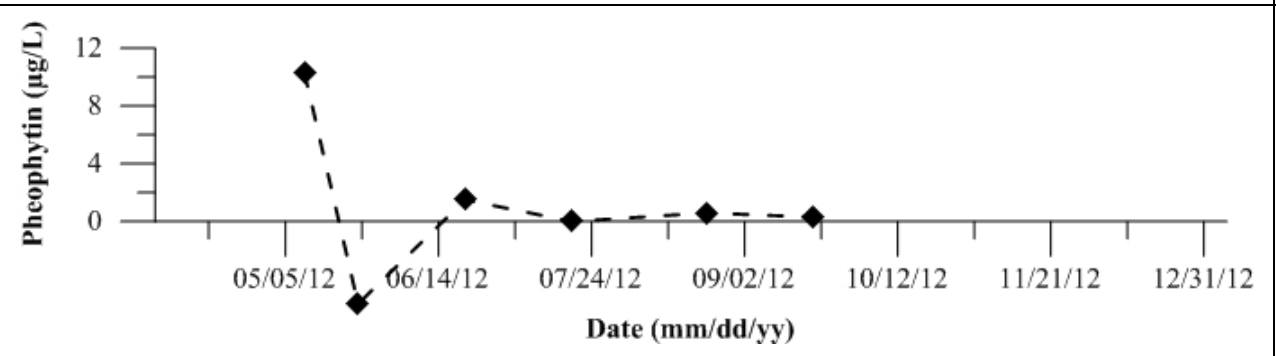
Figure 1738: Pheophytin as determined by spectrophotometric methods for Site 44 San Luis Drain End. Data collected in 2012.

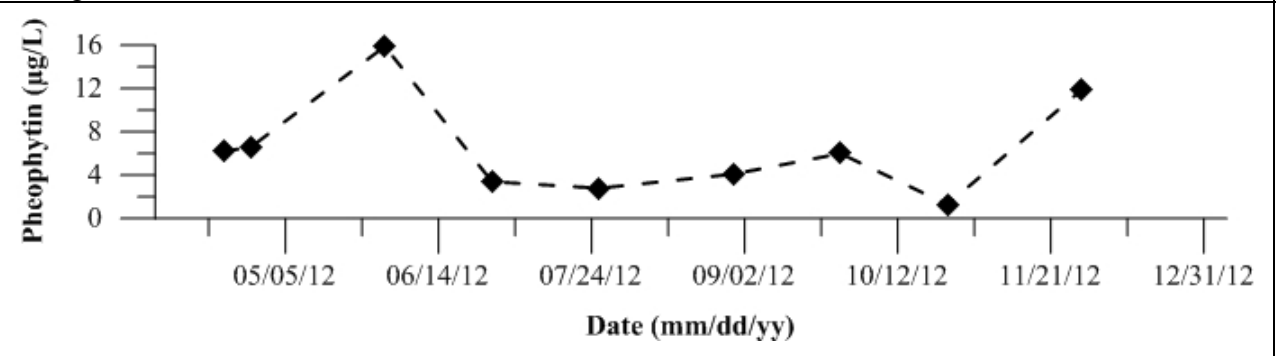
Figure 1746: Pheophytin as determined by spectrophotometric methods for Site 421 5 Mile Slough at Hazelwood Ave. Data collected in 2012.
